NRL Memorandum Report 1427

FRACTOGRAPHY

EXAMINATION OF A

7075 T-6 ALUMINUM ALLOY FORGING FRACTURE

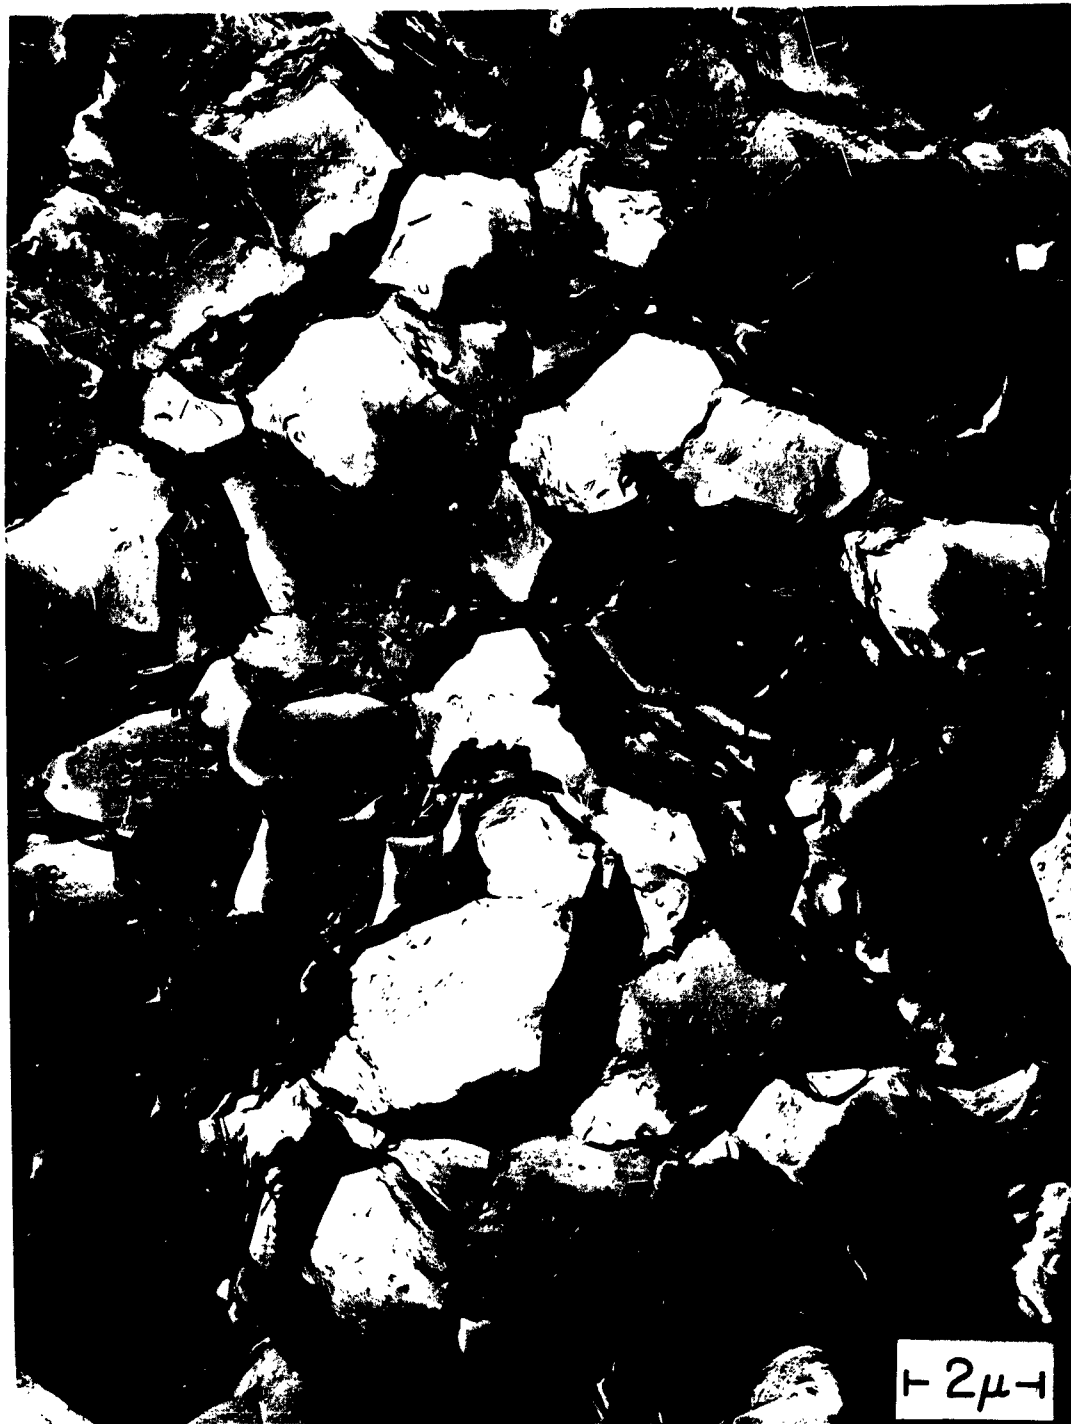
A representative area from the fracture initiation region is shown in Figure 2. The faceted or "rock candy" appearance indicates that the crack propagated along grain or sub-grain boundaries in an intergranular fracture mode. Figure 3 shows the micro-appearance of a representative region in the fast fracture area. The network of small dimples is typical of overload fracture in this aluminum alloy. The dimples result from small voids which tear open in the fracture plane and are thought to be associated with small precipitate particles. No evidence of mechanical fatigue crack propagation was observed

The intergranular fracture mode, the stepped appearance of the fracture profile, and the absence of evidence of mechanical fatigue in the fracture initiation area indicates that the failure in this region resulted from a stress corrosion cracking mechanism. Final fracture of the forging took place when the stress corrosion crack penetrated to a sufficient depth to cause the remaining material to fail through mechanical overload.

Fig. 2 - Intergranular fracture in the crack initiation region.
Magnification 6,000X.

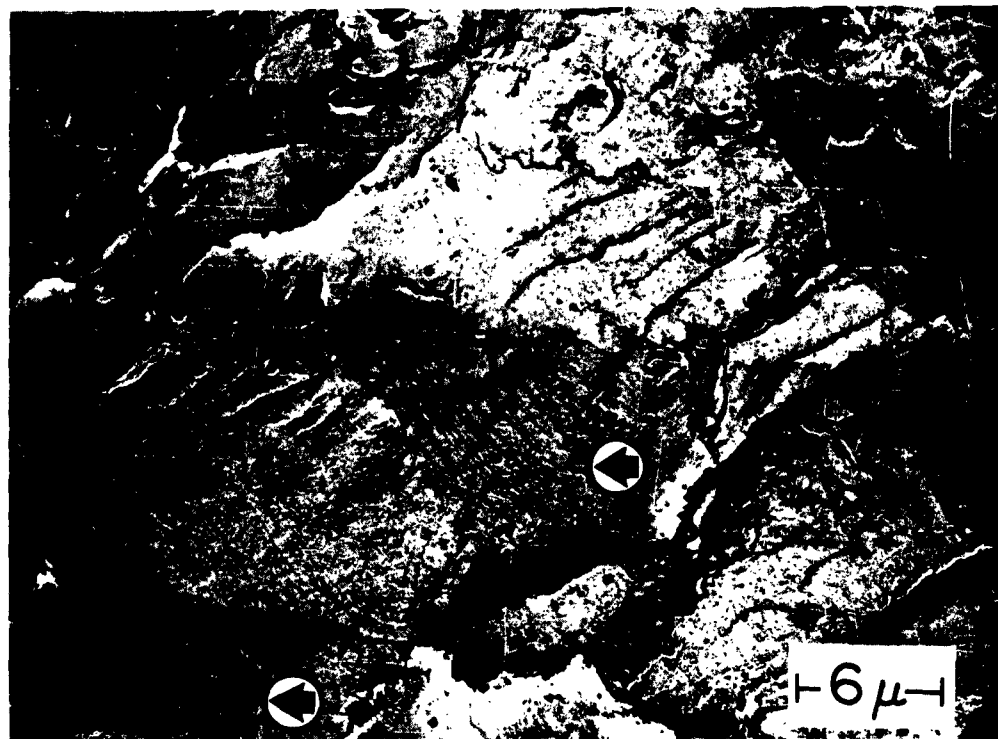
in either area. Such fatigue markings, having been observed on fractures of 7075 T-6 alloys (1) (see Figure 4) subjected to severe conditions of "after the fact" handling and corrosion, would presumably have been observable if the subject failure had resulted from mechanical fatigue.

Fig. 4 - Fatigue fracture markings (arrows) on a 7075 T-6 aluminum alloy dive brake skin. Magnification 2,000X.

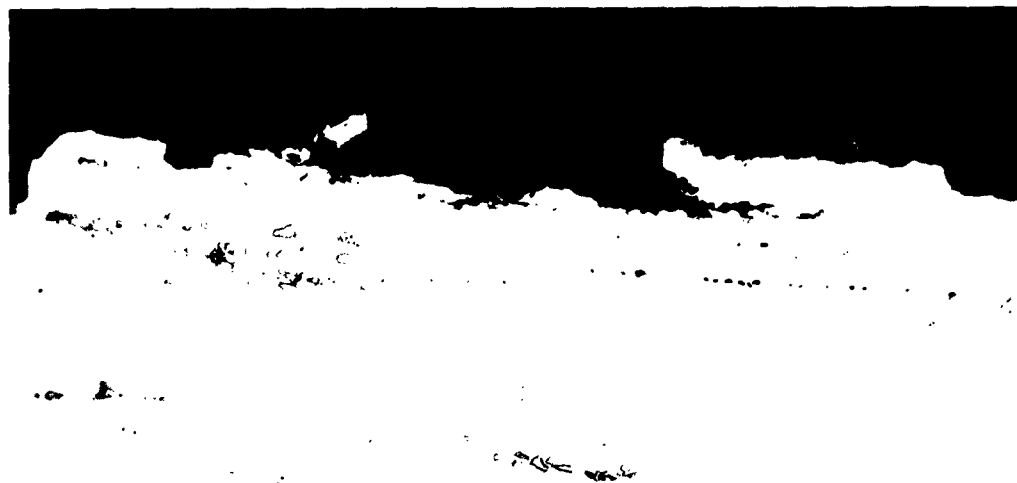
Figure 5 shows a mounted and polished cross-section of a portion of the fracture in the crack initiation region. The stepped fracture profile was generally parallel to the elongated grains and secondary cracks were observed near second phase particles strung out in this direction by the forging operation

Fig. 5 - Cross section of the subject failure showing the fracture profile in the crack initiation region. Magnification 200X.
